AT32F415 device limitations

This errata sheet applies to Artery's AT32F415 series microcontrollers based on an ARM™ 32-bit Cortex®-M4 core.

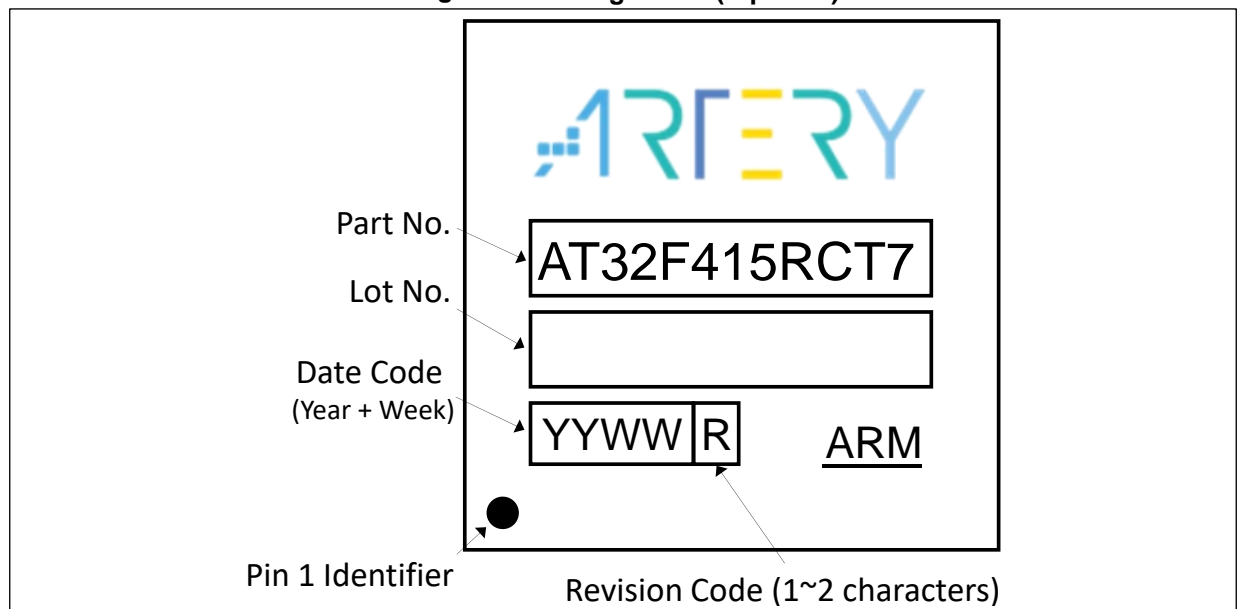
Figure 1. Package label (top view)

Figure 1 shows the location of revision code on AT32F415 device marking. The first code is R (revision code). For example, if B is shown in the R location, it means that the hardware revision of this device is silicon B.
